# Manhole Inspection Summary

Manhole # S33MM\_045MH

Insp Date: **11/28/06 2:55 PM**

**Location** Address: **2000 HOWARD ST**

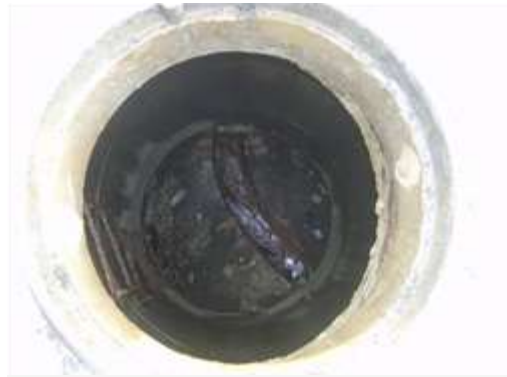
Top View

Corroded steps. Evidence of surcharge - Bench debris.

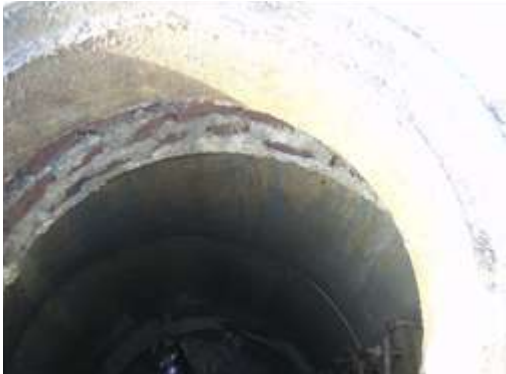
Defect

**Frame** Offset: **0** (in.) Condition: ☐ Sound ☐ Cracked ☒ **Leaks**

Condition: ☐ Sound ☐ Cracked ☐ Root Intrusion ☐ Loose Brick ☒ **Deteriorated**

Infiltration: ☐ None ☒ **Joint** ☐ Cracks ☐ Mortar ☐ Roots ☒ **Wall**

Frame leaks. Adjustment deterioration and infiltration. Barrel infiltration.

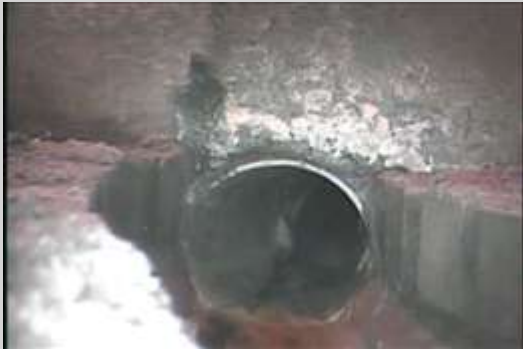
### 8 in. Circular Gravity Sewer Pipe Out @ 12 O'Clock

Infiltration: **Evidence** Pipe Seal Cond: **Unknown**

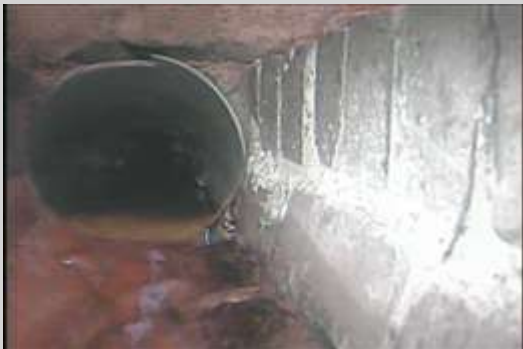
### 8 in. Circular Gravity Sewer Pipe In @ 4 O'Clock

Infiltration: **Evidence** Pipe Seal Cond: **Broken**
